ON-SCENE COORDINATOR'S REPORT

CERCLA REMOVAL ACTION

GENERAL DIE CASTING SITE

DETROIT, MICHIGAN

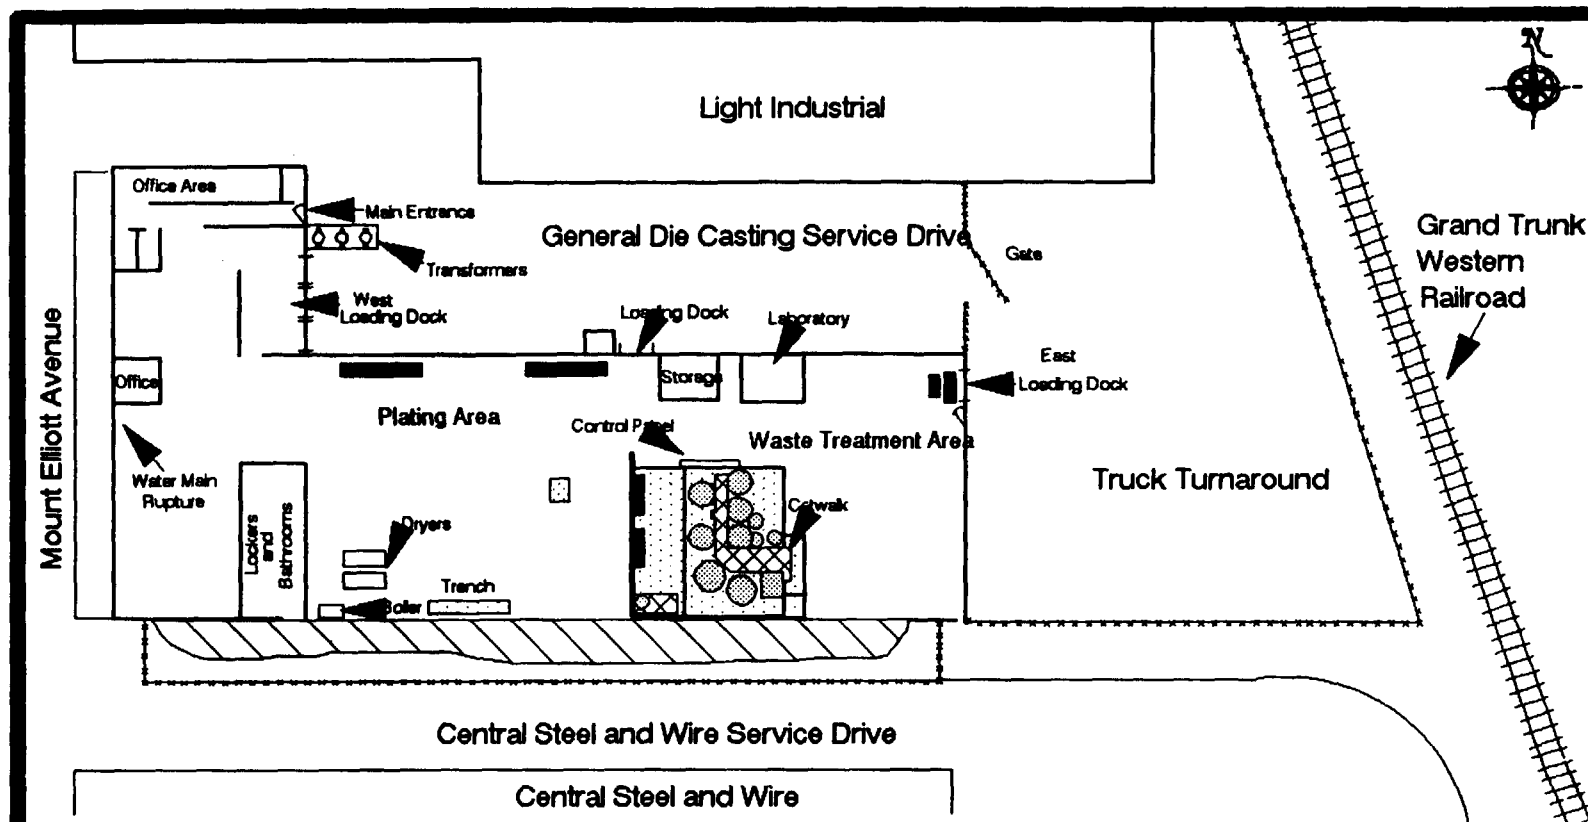
| TITLE | Site Map | FIGURE # | 2 |

The GDC site is a 21,250-square-foot building located on 0.6 acres (Figure 2). The facility consists of a two-story office area connected to a single-story building that includes the electroplating process area (west room) and the waste treatment area (east room). A laboratory and storage room are located in the waste treatment area. A fenced area used as a truck turnaround, loading, and storage area is located behind the building (Figure 2).

A 50-kilowatt portable generator was mobilized as a power source for the office trailer and portable lights inside the building. As part of the set-up of the transition zone, OHM personnel swept the cement area in front of the east loading bay entrance. A black, powdery material, believed to be carbon used for filtration of plating solutions, was observed on the ground over a wide area of the truck turnaround. Two drums of the carbon material were collected. Inside the building, separate areas were created for staging of drums and debris. A drum staging area was established in the room west of the loading bay (Figure 2).

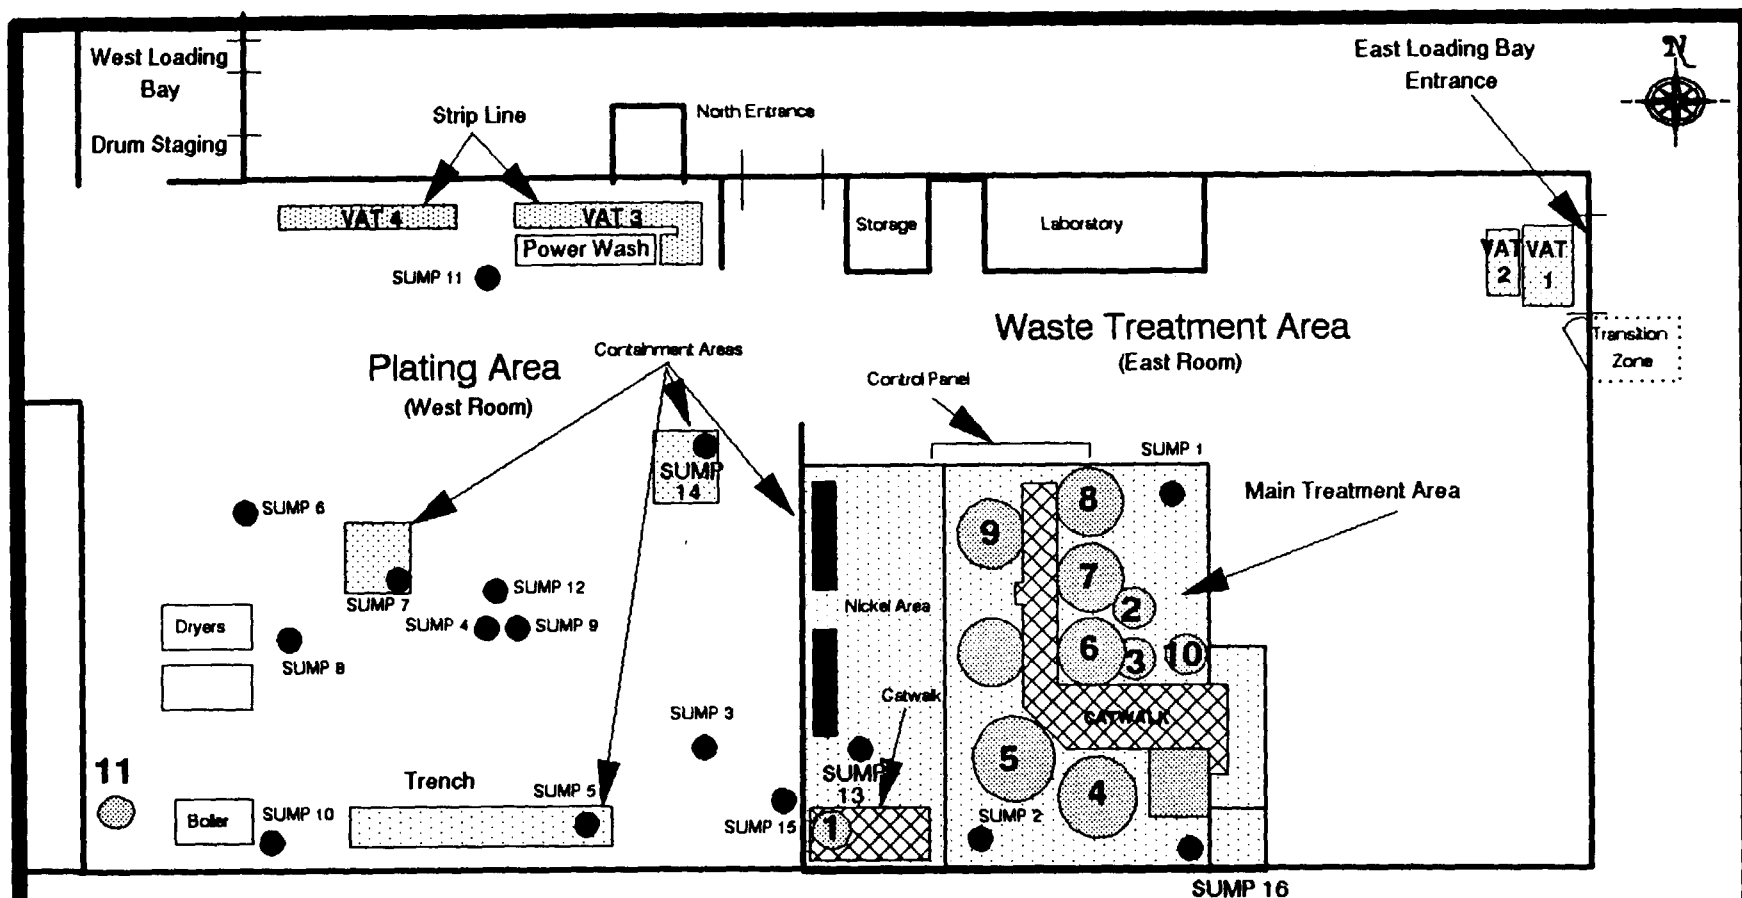
On March 13, 1992, the ERCS subcontractor, OHM mobilized to the site to conduct immediate stabilization measures on materials posing the greatest threat of release. These activities included establishing site security and drumming the green crystalline material and sludge (found to contain 600,000 ppm of cyanide from February 1992 site re-assessment sampling results) from the two containment areas in the east room. Full mobilization occurred on March 16, 1992, and a safety plan was developed and adopted between ERCS, TAT, and U.S. EPA. An office trailer was mobilized on March 16, 1992, as a command post. Work and transition zones were delineated and completed by March 18, 1992 (Figure 3).
